**MARYLAND HISTORICAL TRUST  
DETERMINATION OF ELIGIBILITY FORM**

BA-2328

Carpenter Shop, Spring Grove

# Maryland Historical Trust State Historic Sites Inventory Form

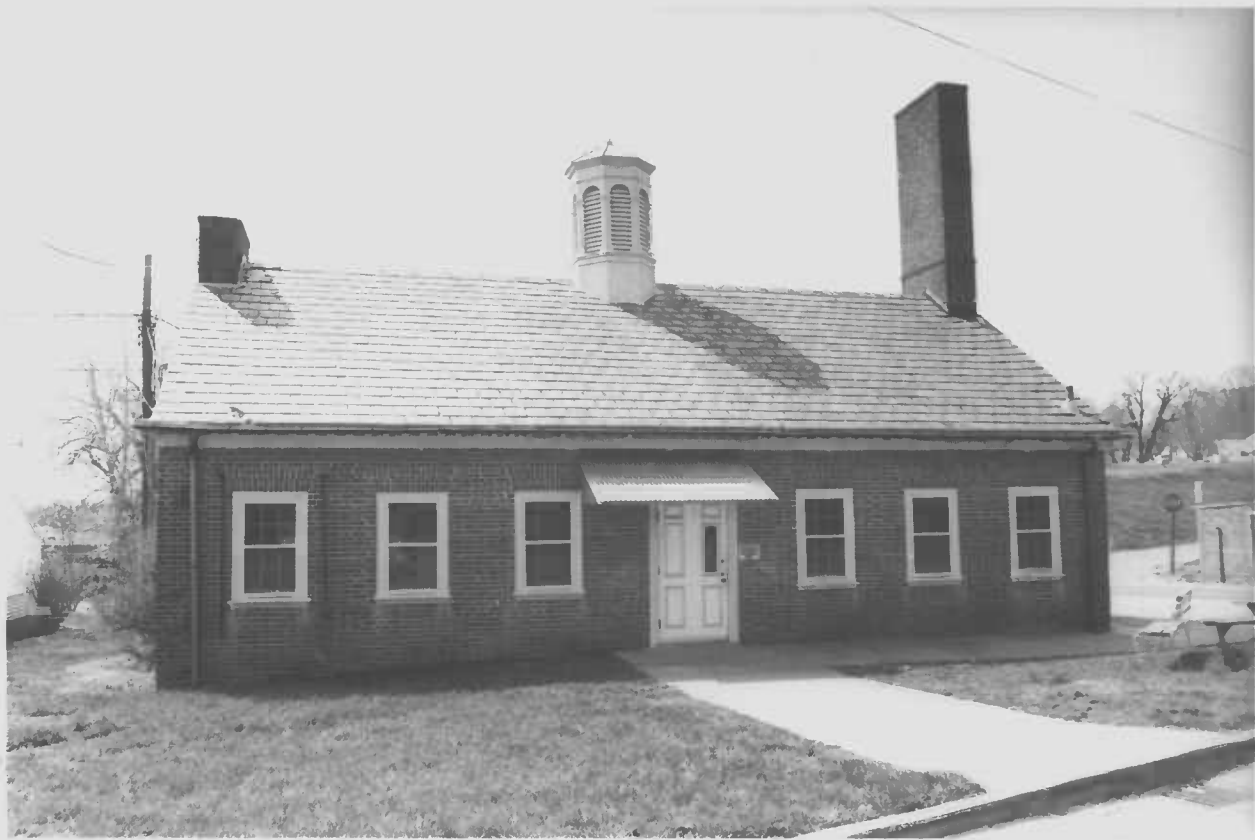
NORTH WALL

The central doorway on the northern side is flanked by three windows on each side. The wooden door has an arrangement of six recessed panels with a wide central rail, a newer wooden sill, and a simple wooden surround. Though not centered over the door, a plastic hood awning protrudes from the brick wall. The awning shadows the brick jack arch lintels. The jack arch lintels also appear over the six windows of the northern face. The windows have a 6/6 double-hung sash. When compared to other examples at Spring Grove, the window sills are more elaborate. The sills have a tiered look: one principal ledge with two receding ledges underneath the first. A full wooden surround frames the window. The window lintels graze the wooden cornice. Though somewhat visually obstructed by a gutter, the entablature is developed with a modillioned cornice.

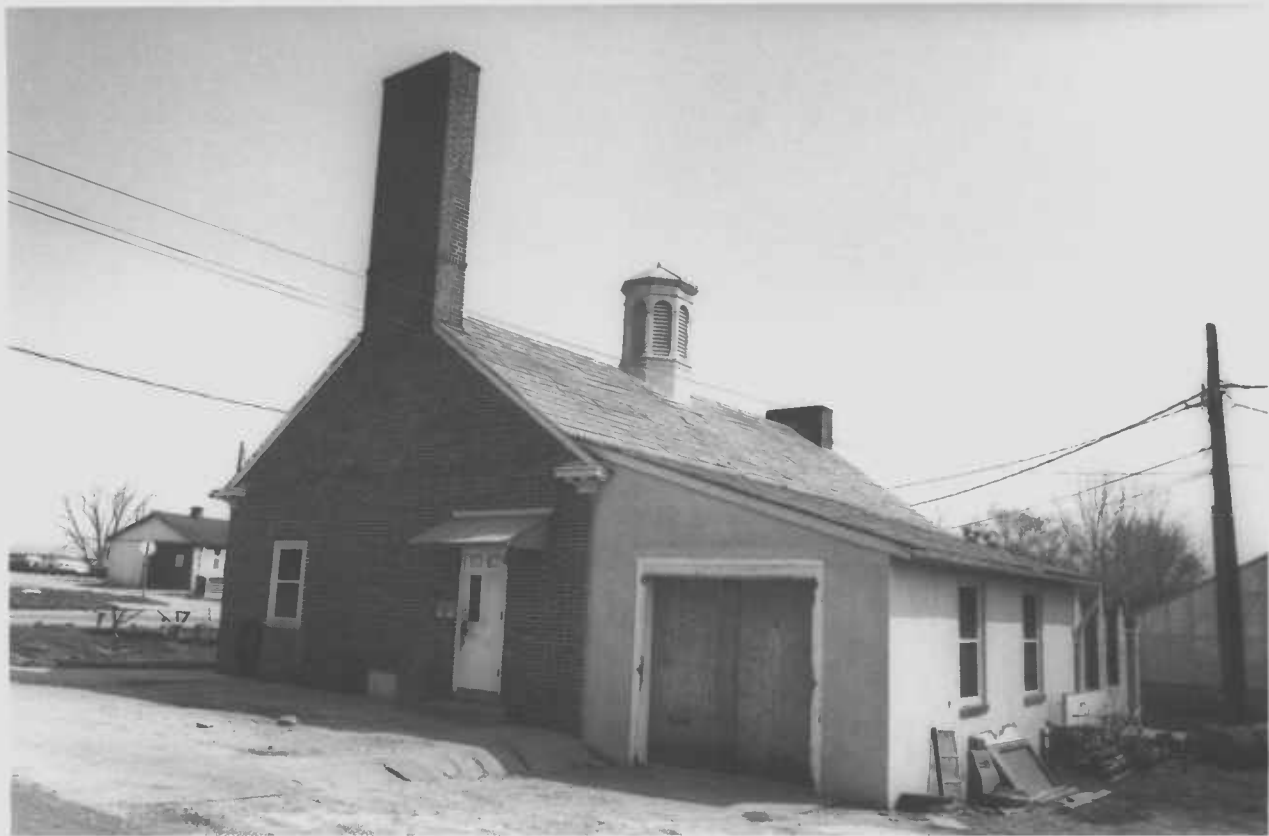
WEST WALL

The eaves on the east and west faces have a cornice fascia treatment. The gable end also includes boxed returns with the modillioned cornice. The flush wall chimneys interrupt the crest of the gable end. The chimneys differ in height considerably, the west chimney runs twice as tall and is distinguished by two horizontal bands of stretcher bricks. The windows which exist on both of the gabled ends exhibit the same treatment as the windows on the north face: jack arch lintels, elaborate wooden sills, and the 6/6 sash. In addition, these windows have full length outer screens. The western wall shows a door which shares many characteristics of the door on the northern face. Though narrower, the door retains the same panel configuration. The jack arch lintel is once again shadowed by a plastic hood awning.
